Improved methods for deterring cliff swallow nesting on highway structures

Abstract: Cliff swallows (*Petrochelidon pyrrhonota*) are migratory birds that frequently nest on highway structures, such as bridges. Because cliff swallows are protected by the Migratory Bird Treaty Act of 1918, nesting control methods must not harm cliff swallows or disturb active nests. This can cause delays for maintenance divisions of state departments of transportation, resulting in additional cost. In a multiyear project, we evaluated the effects of bioacoustic deterrents and bridge surface modifications on nesting behavior of cliff swallows. We used cliff swallow alarm and distress calls as bioacoustic deterrents (hereafter, broadcast calls [BC]) because they previously had been shown to delay the onset of nesting. We used low-friction plastic sheeting (PTFE, commonly called by its trade name, Teflon®) and silicone-based paint for bridge surface modification. In 2007, swallows were able to complete nests on silicone paint, but did not successfully complete any nests on PTFE. In 2008, PTFE+BC treatment significantly reduced nesting compared with no treatment, although some nests were completed at PT

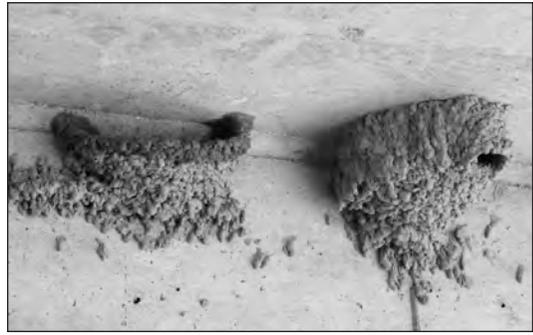
Figure 1. Partial (left) and completed cliff swallow nests on the underside of a bridge.

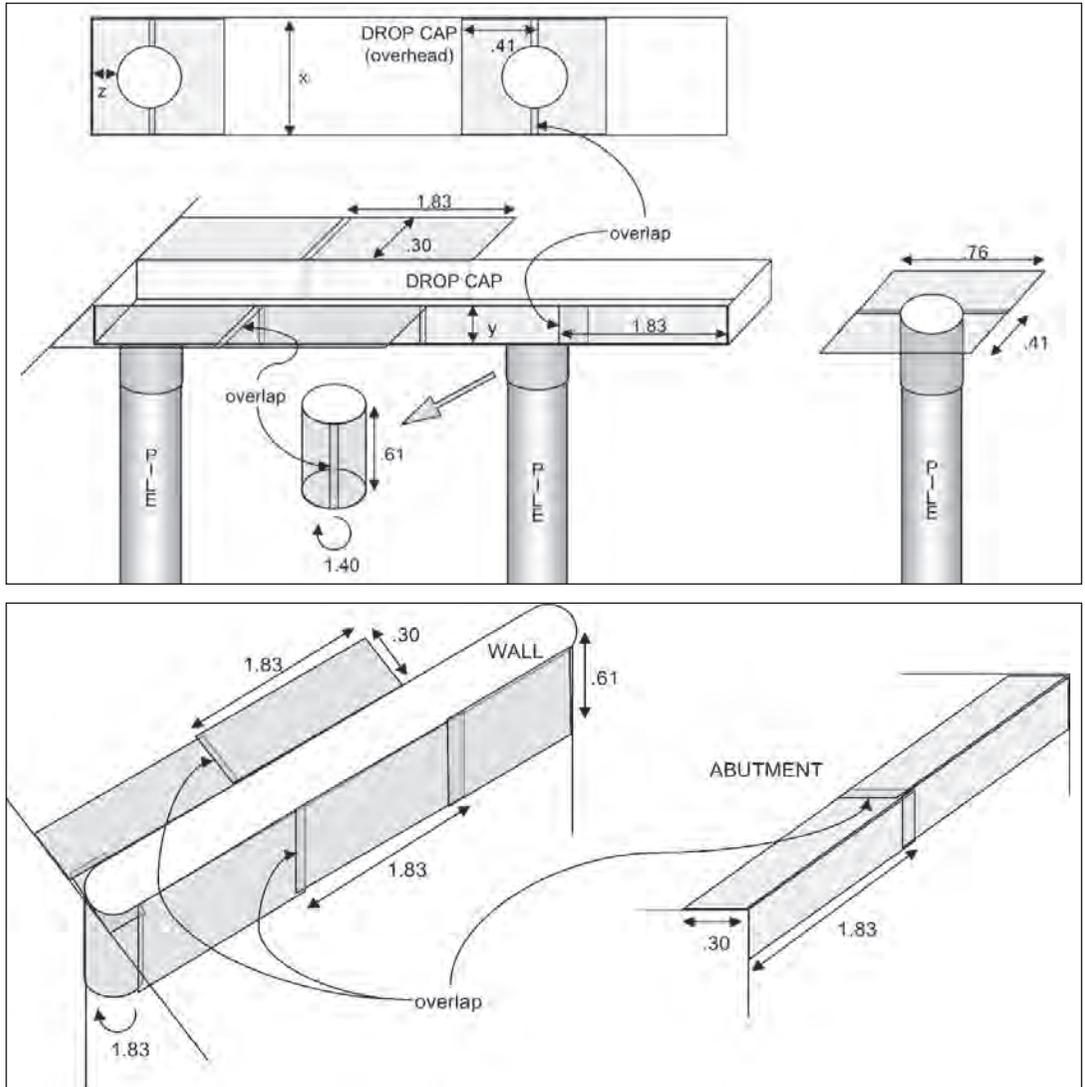
Figure 2. Locations of surface modifications on highway structures with piles and pier walls. Dimensions x, y, and z (top) varied depending on the site. Dimensions in meters; not to scale.

^bRefer to Figure 2 for explanation of pile, drop cap, and pier wall.

nests on the vertical surfaces below the edge of PTFE sheets and on the overhead surfaces along seams in the concrete. These nests were included in the count data and reflect the actual effectiveness of PTFE to deter cliff swallow nesting when used only at typical nesting locations (e.g., Figure 2).

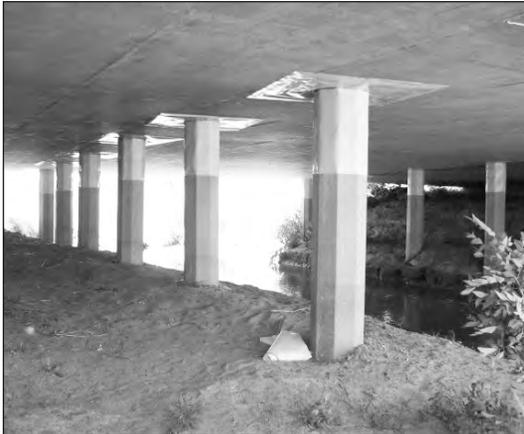
Figure 3. Highway structure with PTFE surface modification.

PTFE sheets used for surfaces above pier walls and drop caps were 61-cm wide for sites in 2007 and the first few bridges in 2008, after which we reduced the sheet width to 30 cm for the remaining bridges. PTFE extended 61 cm down each pile and at least 18 cm from the overhead juncture above the pile. We limited the length of sheets to 1.83 m for ease of handling. We applied the butyl adhesive strips along the edges and interior of each sheet so that any point on the sheet was no farther than 15 cm from an adhesive strip. We removed the paper backing of the butyl strips and pressed the sheets against the bridges' surfaces (Figure

3). We overlapped sheets 3 to 6 mm to provide continuous coverage of each surface with PTFE.

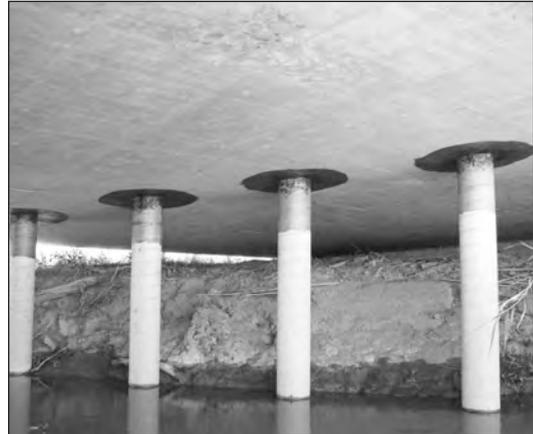
Figure 4. Highway structure with silicone paint surface modification.

We applied silicone paint at locations similar to the PTFE placement, extending it 61 cm down piles and 46 cm out on the overhead surface (Figure 4). We also covered up the surface around drop caps up to 46 cm out from the juncture. We stirred the paint for 2 minutes, then applied it to the surfaces using 1.9-cm nap paint rollers and paint brushes for the corners. The paint cured within several hours of application.

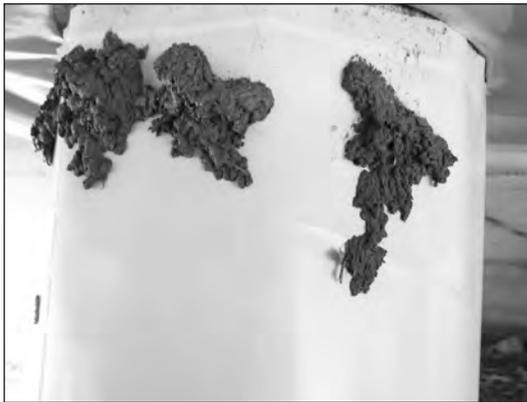
Figure 6. Nest mud sliding down surface of PTFE on a pile.

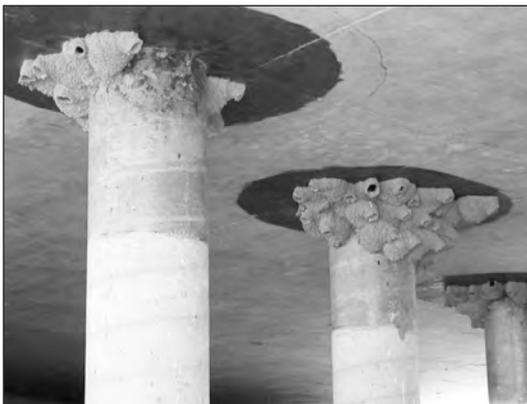
Figure 7. Completed nests on piles and overhead surfaces treated with silicone paint.

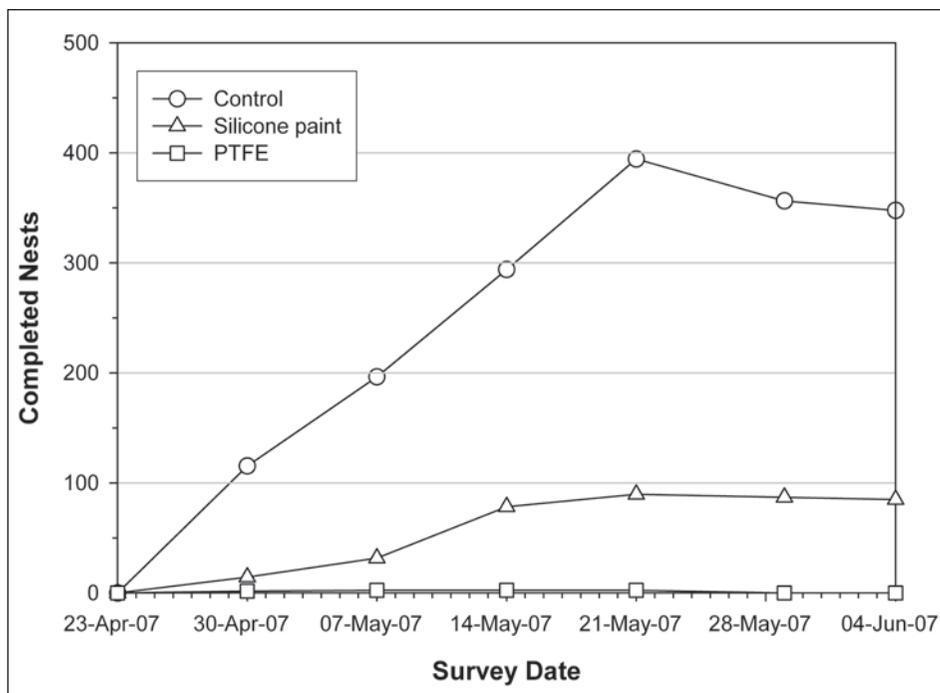
Figure 8. Average number of completed nests over 7 weeks in 2007.

Nest building ceased at all sites by week 7 of the study, so we used nest counts from the seventh survey for statistical comparison. The mean number of completed nests (Figure 8) for each type of treatment was: PTFE (0), silicon paint (85), and control (348). Statistical tests indicated that the treatment means were not equal ($P = 0.006$) and the PTFE and control treatments means differed ($\alpha = 0.05$).

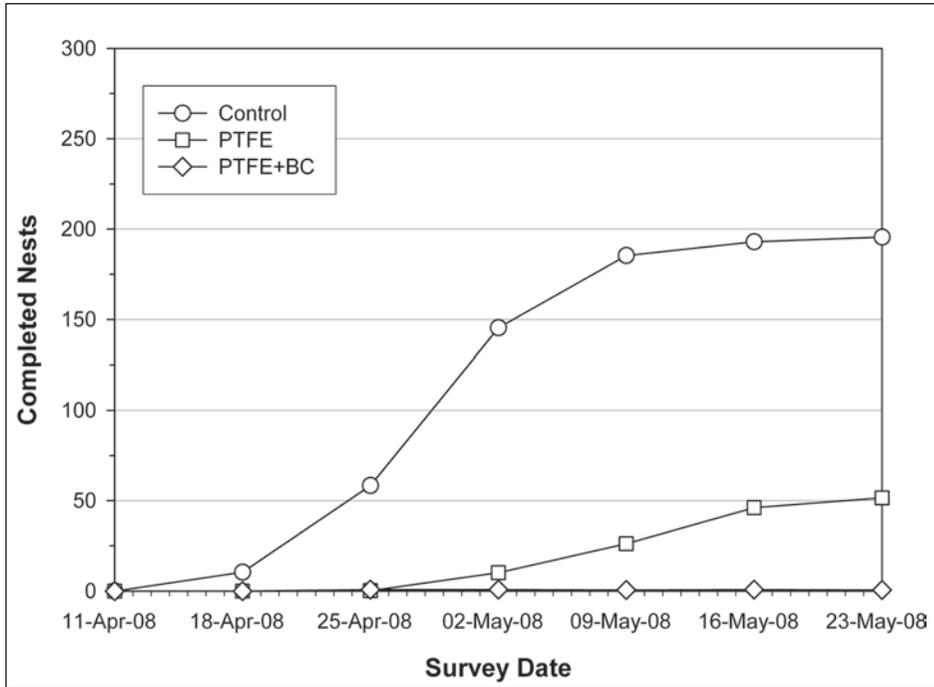
Figure 9. Average number of completed nests over 7 weeks in 2008.

at either PTFE or PTFE-BC sites were found on bare concrete. To be consistent with the 2007 analysis, we decided to do the statistical analysis on nest counts collected during the seventh survey and also because the PTFE sheeting was detaching from the bridge surfaces and could not be replaced quickly enough to maintain the integrity of the treatments. Furthermore, nest building at control sites had virtually ceased by the seventh week. Average completed nests over time for each treatment in 2008 are shown in Figure 9. At the seventh survey, the mean number of completed nests was 1 for PTFE+BC, 52 for PTFE, and 196 for the control. Statistical tests indicated that the treatment means were not equal ($P = 0.002$) and the PTFE+BC and control treatment means differed ($\alpha = 0.05$).

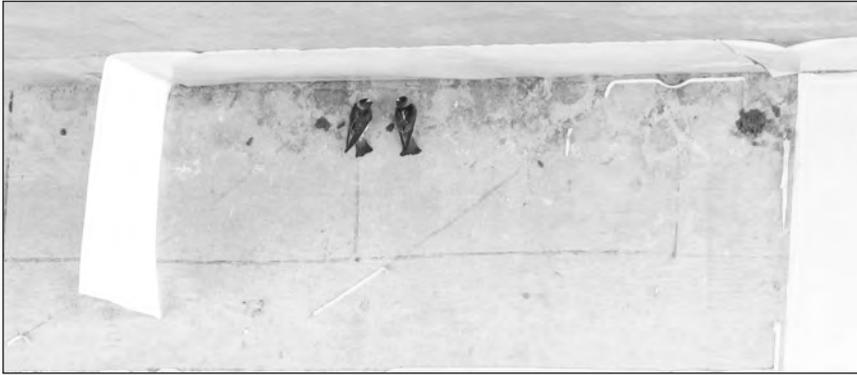
Figure 10. PTFE sheets detaching from the concrete bridge surface and cliff swallows building nests.

that both the PTFE and PTFE+BC treatments would have been more effective if it were not for problems with PTFE sheet adhesion to the bridge surface (Figure 10). Many of the detached sheets were installed overhead, such that the weight of the sheet pulled directly away from the bridge surface. We replaced missing PTFE sheets as quickly as possible during the first 7 weeks of the study, but at some sites we were unable to replace the sheets before the birds had built nests at that location. We included these nests in our counts, but they do not reflect the intrinsic ability of PTFE to deter nesting, assuming it is securely attached to the surface. Butyl adhesion failed at the concrete surface and at the PTFE surface in about equal proportions. This suggests that butyl sealant is not adequate for reliable surface modification treatments as conducted in this study. Thinner or smaller sheets of PTFE, or additional strips of butyl adhesive might prevent detachment from the bridge surface, but we feel that a better attachment method is needed, such as mechanical fasteners or semi-permanent epoxy adhesive.
